Structural safety and failure modes in Gothic vaulting systems

Dimitris THEODOSSOPOULOS¹, and Braj SINHA²

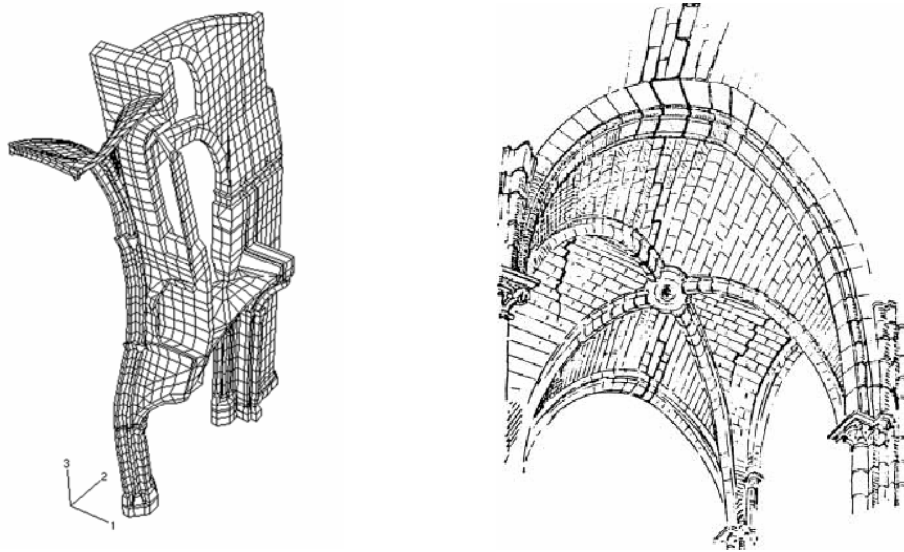
Lateral instability is the predominant source of failure in Gothic churches and often results from design errors, erroneous interventions or neglect. If typical cross sections are considered to represent the transverse behaviour of naves, its pathology (Fig. 1) is mainly triggered by failing flying buttresses or excessive increase of vault thrusts against the buttresses. The vaults are affected by the spread of their supports (outwards at the upper portion, inwards at the aisles) producing crack that can be summarised in Fig. 2: usually a hinge line forms along the intrados with a transverse detachment following at the wall edge and abutments. The progressive failure of the vault is further accelerated by the instability of the elevation due to its slenderness.

Figure 1. Deformation patterns in Gothic buildings: left, Burgos Cathedral FE model, magnified 200 times [Theodossopoulos 2004]; right, typical crack pattern established by Pol Abraham [Heyman 1995]

The FE model of Burgos Cathedral (Fig. 1) indicates a similar location of maximum displacement, although the value is much lower (2 mm). The difference is due not only to the fact that a linear elastic analysis was performed that ignored creep or settlements but also to the presence of more efficiently designed buttressing.

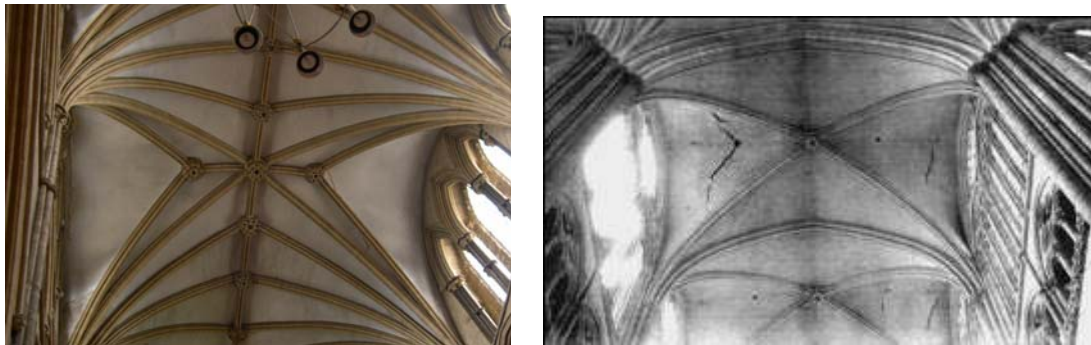
Figure 2. Crack patterns in the high vaults of Lincoln and Amiens Cathedrals

In Lincoln Cathedral the crack pattern in Figs 2 and 3 can be seen today. Especially at bay 8F there is a strong detachment of the fabric from the tierceron ribs and fragments of plaster have also fallen (Fig. 2). However, the out-of-plumb of the outer wall is within reasonable limits (Table 1). Timber edge beams have been placed at the North side of the nave wall between bays 4F and 7F indicating a local weakness [Bailey 1996] that is probably the origin of these cracks. This pattern is often encountered in major scale cathedrals: cracks initiate at the intrados parallel to the longitudinal vertex followed by extrados cracks above the springings, forming ultimately a 3-hinge mechanism that leads to collapse. Laboratory tests [Ortolani 1988, Theodossopoulos et al 2002] and FE analysis on case studies both have verified this pattern, as will be seen in later sections.

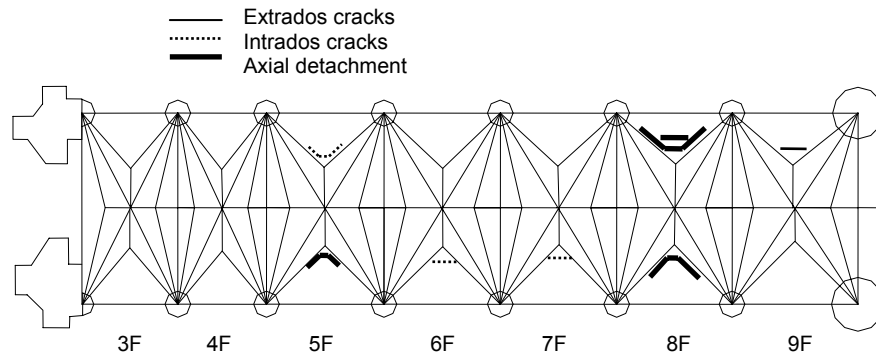
Figure 3. Crack pattern, nave of Lincoln Cathedral (after Bailey 1996)

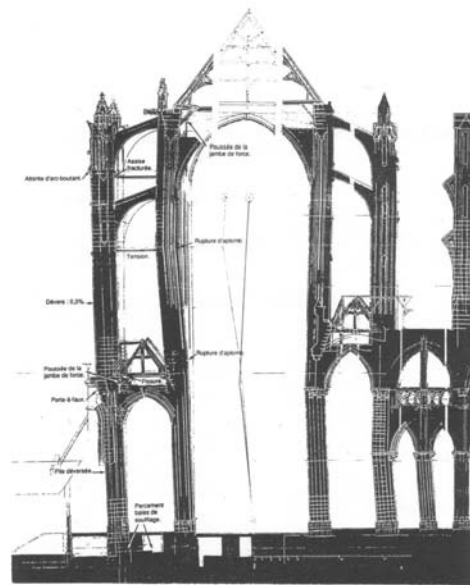
Two classic examples where errors in the design had almost a catastrophic effect are Beauvais and Vitoria cathedrals. The partial collapse of the extremely slender piers in the former in November 1284 and the excessive deformations that can be still observed today [Taupin 1993] traditionally highlight the limits in the proportions a Gothic church could reach (Fig. 4). Various hypotheses on what triggered the collapse have been put forward by S. Murray [1989] or J. Heyman [1995], like the configuration of the porte-a-faux junction of the upper structure towards the aisles or the location of the flying buttresses. The very slender design is still subject to accelerating deformations and vibrations today that have to be constantly monitored at three levels across the building.

Figure 4. Horizontal displacement in the North transept of Beauvais Cathedral [Taupin 1993]

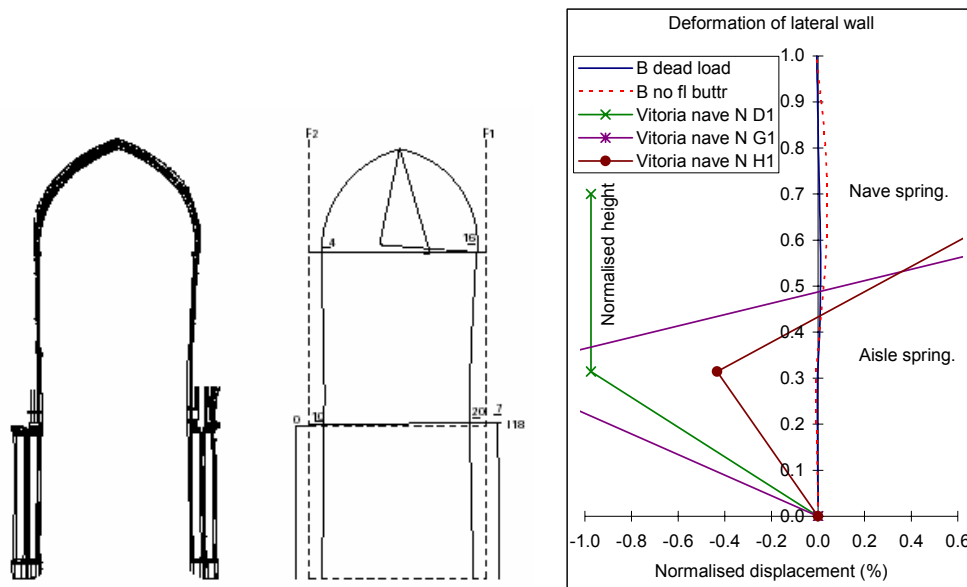
Vitoria Cathedral clearly illustrates a typical problem of Gothic architecture, i.e. the addition of flying buttresses after significant lateral deformations have developed. In this case even such a remedy was not enough and a series of arches were built in the nave above the ridge line of the aisle vaults. Only recently, a comprehensive programme of interventions was developed to strengthen the fabric and in that occasion the movement of the church was carefully monitored (Fig. 5). The distorted configuration of the elevation corresponds clearly to the pattern expected due to insufficient containment of the upper thrusts and eventually deformations of this scale were impossible to cancel even if strengthening of the buttressing was applied.

Figure 5. Deformed lateral elevation of Vitoria Cathedral [Azkarate 2001] and comparison of the lateral displacement of Vitoria and Burgos Cathedral, normalised against the span

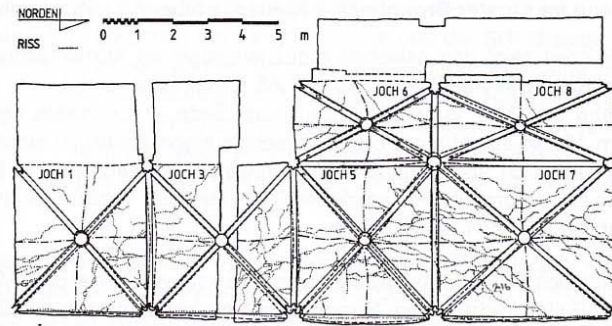
Figure 6 reports the crack pattern in Kloster Maulbronn due to the instability of the outer walls. The Dormitory is a single story building, without upper structures and the observed deformation indicates clearly the sensitivity of cross vaults to the conditions of their supports. Several German case studies are discussed by Jagfeld [2000].

Figure 6. Crack pattern at the Dormitory in Kloster Maulbronn [Jagfeld 2000]

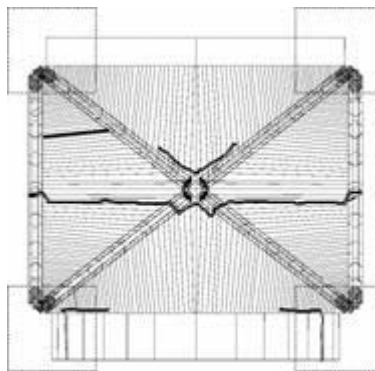
Figure 7. Experimental crack pattern in a model simulating the aisle vaults of Holyrood Abbey Church [Theodossopoulos et al 2002]

An experimental study of the church collapse [Theodossopoulos et al 2002] verified the values and gave useful insight to the development of the cracks that transform the structure into a mechanism (Fig. 7). The study concentrated on the aisle vaults and the typical longitudinal cracks and detachment of the vault from the back ribs were initially observed. Next, hinges formed above the springing, accompanied by detachment of the back web from the wall, confirming the development of the so-called Sabouret's cracks in the areas of rigid supports [Heyman 1995]. Failure of the vault occurred at 30 mm movement, although the structure did not collapse as a result of interlocking of the webs with the ribs.

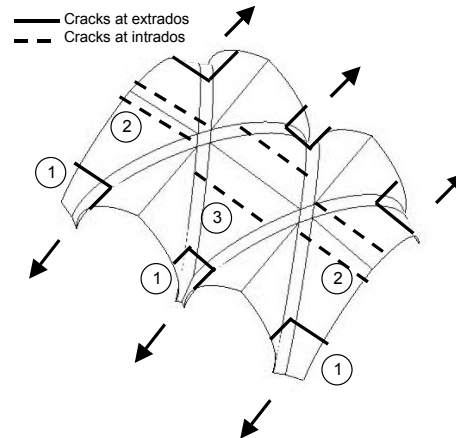
Structural interpretation of the origin and propagation of failure was also attempted using structural analysis of major early English cathedrals (Durham, Lincoln, Wells, Canterbury), simulating the geometric instability as a movement of the supports and using a biaxial failure criterion for the stone masonry, as developed in the case of Holyrood [Theodossopoulos 2008]. The typical failure pattern that developed in most cases is illustrated by Durham in Fig. 8 and the values of the support spread are reported in Table 3. The FE models show good agreement with the in-situ observed patterns, and they can also provide information on the rate of failure: in most cases the first cracks appeared above the supports, followed by cracks along the longitudinal ridge.

Figure 8. Crack pattern from the FE model of Durham Cathedral choir vaults at a supports spread of 330 mm [Theodossopoulos 2008]

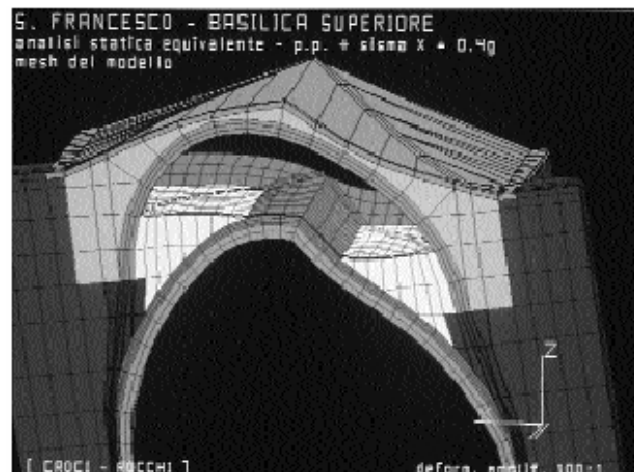
Figure 9. High deformation of a vault from St. Francis Basilica [Crocì 1998]

The well documented collapse of two vaults at St. Francis Basilica in Assisi in September 1997 has been supported by extensive 3D FE modelling that was used for the interpretation of the collapse and the design of the strengthening interventions [Crocì 1998]. The study confirmed that excessive volumes of the loose spandrel fill were able to shift during the acceleration and load non-uniformly the shell, increasing the tensile stress close to the vertices of the vault and causing unrecoverable curvature inversions (Fig. 9). Considering various structural schemes for the collaboration between the ribs and the shells and the action of the spandrel fill, the collapse was attributed to rather inherent incapacity of gothic vaulted structures to withstand lateral actions that disturb its intuitively conceived almost form-active geometry. In another case, the collapse of the Cathedral of Sant'Angelo dei Lombardi after the 1980 earthquake of Irpinia, Italy (Fig. 10) illustrates the similarity of the damage pattern caused by the transverse component of the seismic action to that of the imposed deformations reported earlier.

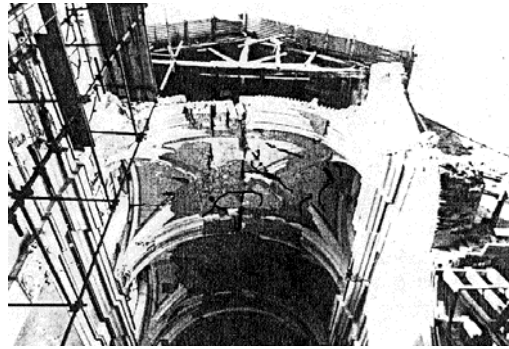
Figure 10. Crack pattern at the nave of Sant'Angelo dei Lombardi Cathedral [Giuffré 1988]

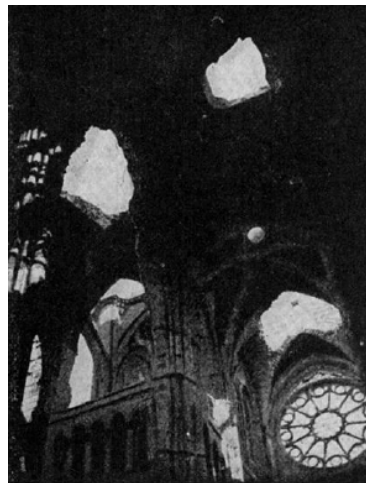
Other sources of failure include accidental loadings like shelling of Rheims, Soissons, Noyon cathedrals during warfare in 1915 [Gilman 1920], sharp changes in the water table (York Minster) etc. Shell fire damages on the upper structure can have an immediate effect to the rest of the structure as a sudden loss of equilibrium of the lateral wall. It was however the direct hits from shelling during the First World War that, apart from the shocking effect on the population, not only made clear the dynamic equilibrium of the parts but also revealed some fundamental aspects of the relationship between the masonry shell and the ribs in the behaviour of a vault.

Figure 11. Shell holes in the vaults of Rheims Cathedral [Gilman 1920]

As expected, such structures have a high degree of redundancies, when compared to modern concrete shells. It is interesting however to observe that the rib actually functions as a reinforcement to the vault. The localised damage shows that ribs being built within the masonry provide relatively substantial stiffness at the adjacent areas, resulting in a solid abutment rather than a subtle reinforcement against excessive bending, as some contemporaries viewed it. This behaviour became also obvious in the failure development as monitored at the Holyrood Abbey experiments, where a hinge formed above the stiffer area of the springing (tas-de-charge).
